October 20, 2021

Tipton High School Light Pole Assessment

WJE No. 2021.6711

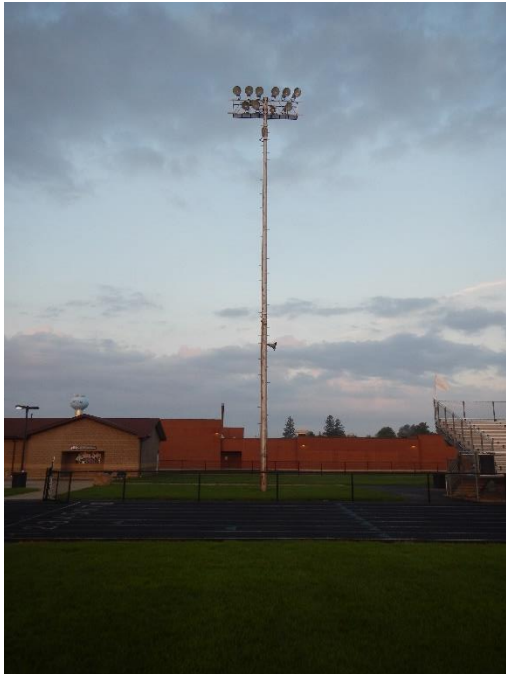
Figure 2. View of Southwest Pole looking west.

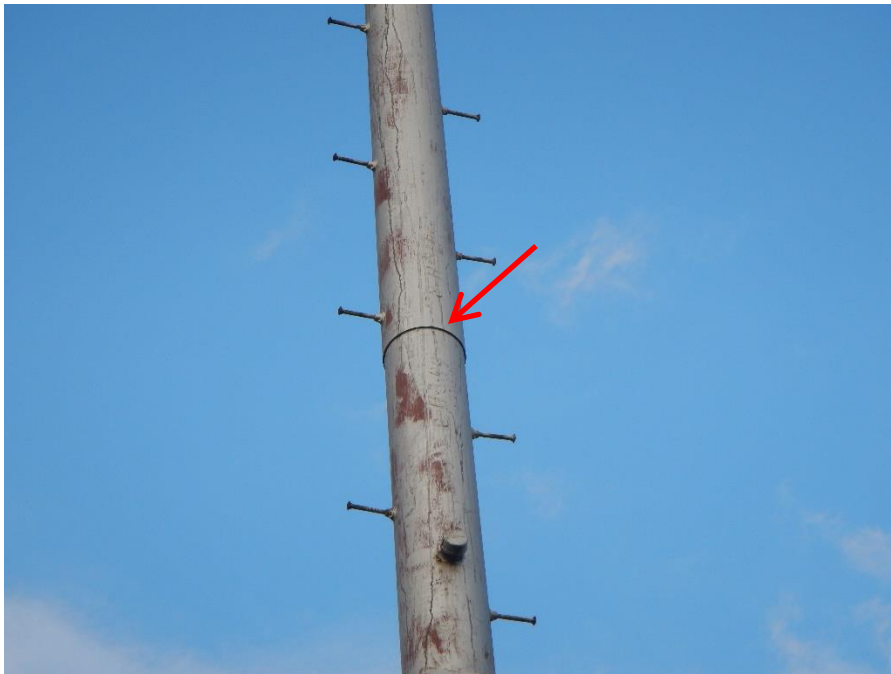
Figure 3. Slip-fit joint at mid-height of pole.

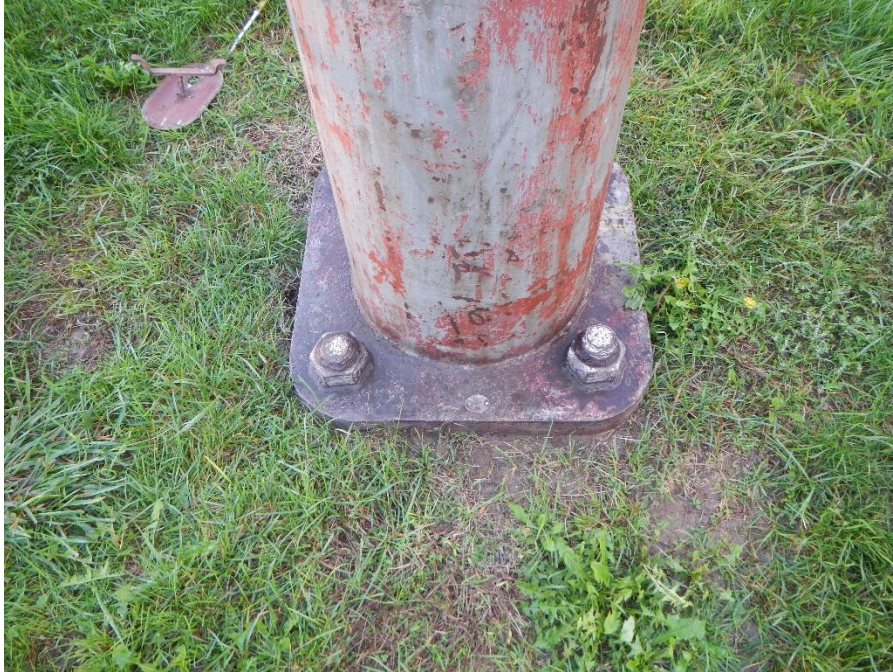
Each pole is welded to a base plate that has a hole centered under the pole. The base plate is 24 inches square with rounded corners and a thickness of 2 1/2 inches (Figure 4). Soil covered the supporting foundation and base plate at many of the poles, but it is believed each pole is connected to a concrete foundation although the construction details on the concrete foundation are unknown. The poles are attached to their foundations via four, two-inch diameter anchor bolts. A hand hole exists near the base of each pole to allow access to the interior. Figure 5 shows a typical hand hole with its cover removed at the base of a pole. Although obscured by soil at many of the poles, it appears the space between the

Figure 4. Base plate and anchor bolts at base of pole.

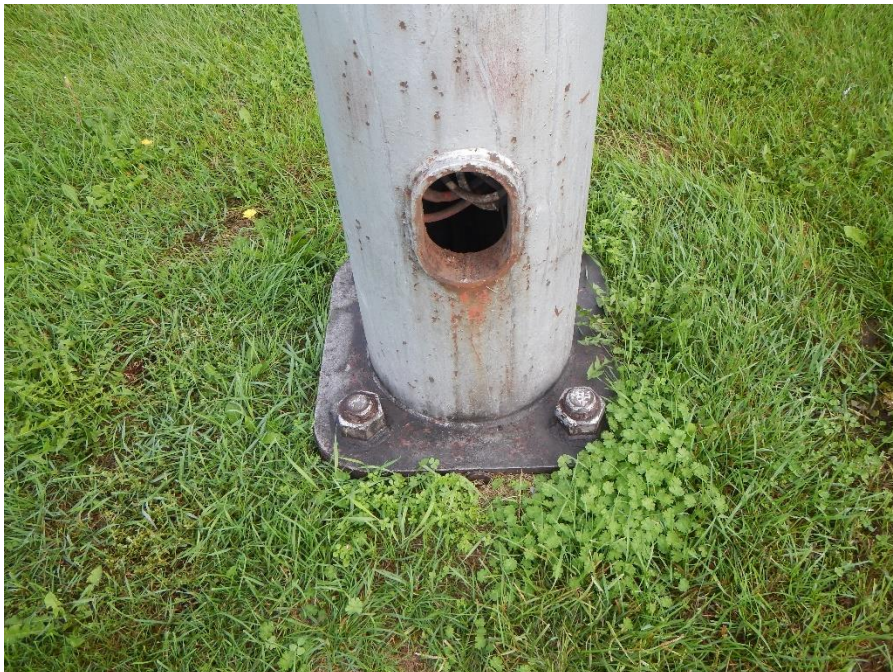
Figure 5. Typical hand hole at the base of a pole after removal of the cover. Note soil covering the top of the concrete foundation.

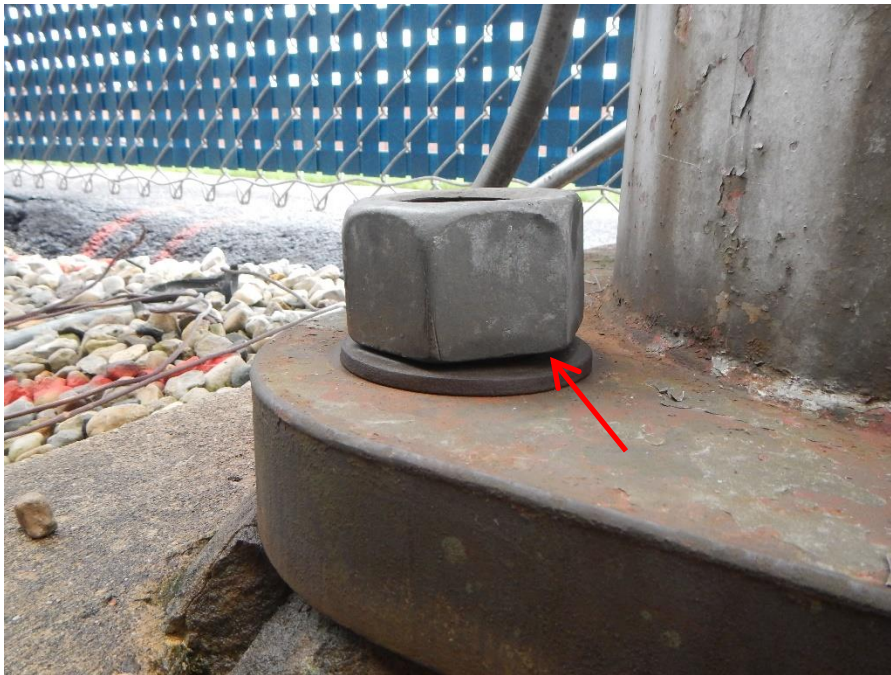
- **Loose and Partially Engaged Anchor Bolt Nuts:** All four nuts at the West Middle Pole were loose and could be loosened by hand. Figure 6 shows a nut with a gap between the nut and washer. Additionally, one of these loose nuts was only partially threaded onto the anchor bolt (Figure 7) and the top surface of the anchor bolt at two other nuts was slightly recessed below the top of the nut. The nuts at the West Middle Pole were taller than those at the other poles. Additionally, the nuts at the West Middle Pole were hot-dip galvanized instead of painted as was observed at all other poles.

Figure 6. Nut at West Middle Pole with a gap between the nut and washer.

- **Loose Nuts:** Nuts can loosen over time if not properly tightened or otherwise restrained. Loose nuts like those observed at the West Middle Pole can have many adverse effects. When a nut is loose, the associated anchor bolt carries little or no load, which can result in overload of other bolts and/or the base plate. When all nuts are loose, the pole can move laterally and/or rotate. Such movements can deform anchor bolt threads, bend anchor bolts, distort base plates and lead to impact loading of the anchor bolts and base plates if the pole is allowed to rock about its base. Impact loading significantly increases the load applied to anchorage elements and can potentially exceed element capacities and/or cause the formation of fatigue cracks which develop due to repeated load cycles at stress levels well below the yield strength of affected materials. Rocking of the West Middle Pole was not observed during the assessment, but it is plausible rocking does occur under certain wind conditions based on the observed separation between the nut and base plate.

1. Loose Nuts: Due to the possibility of rocking and the associated increased potential for cracking of the anchor bolts due to fatigue loading, it is recommended that non-destructive testing (NDT) of the anchor bolts at the West Middle Pole be performed. The NDT should employ ultrasonic flaw detection equipment to inspect the interiors of the anchor bolts to identify flaws that may be present. This work may require temporary removal of the nut where it projects above the top of the anchor bolt to provide access to the anchor bolt. If flaws are observed, repairs should be developed as required to address the conditions observed.

If no flaws are detected during the NDT, we recommend that all nuts at the West Middle Pole be tightened. Although the light poles are not transportation structures, poles of this type are typically designed in accordance with The American Association of State Highway and Transportation Officials (AASHTO) *LRFD Specifications for Structural Supports for Highway Signs, Luminaires, and Traffic Signals* (AASHTO Luminaires Specification). Therefore, we recommend tightening all nuts in accordance with Table C15.6.3-1 of the AASHTO Luminaires Specification which has been reproduced in Figure 22.

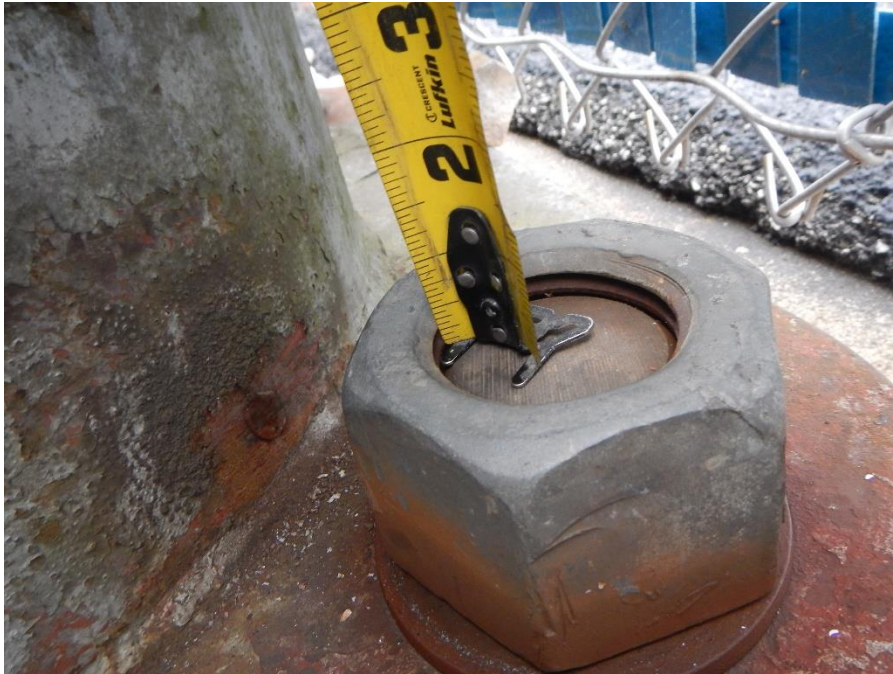
Figure 7. Partially threaded nut at West Middle Pole.

- **Recessed Nuts:** It appears the nuts at the West Middle Pole have been replaced as evidenced by their greater height and hot-dip galvanized coating as compared to the painted coating at other nuts. The greater height may account for why one of the nuts is only partially threaded and two other anchor bolts are slightly recessed below the nut. This is further exacerbated by the fact that the nuts are loose as discussed above. Although one of the nuts is not fully threaded, it likely engages a similar number of threads as the original nut and therefore provides a similar capacity to the original nut. The

recessed area above the anchor bolt can trap water leading to accelerated corrosion of the anchor bolt and nut.

2. Recessed Nuts: After tightening of the nuts as recommended in Item 1, the recessed areas above the anchor bolts created by the projecting nut will be reduced but will likely not be eliminated. Where the recessed areas remain, we recommend they be filled with silicone sealant to prevent the accumulation of water and debris and reduce the potential for accelerated corrosion.

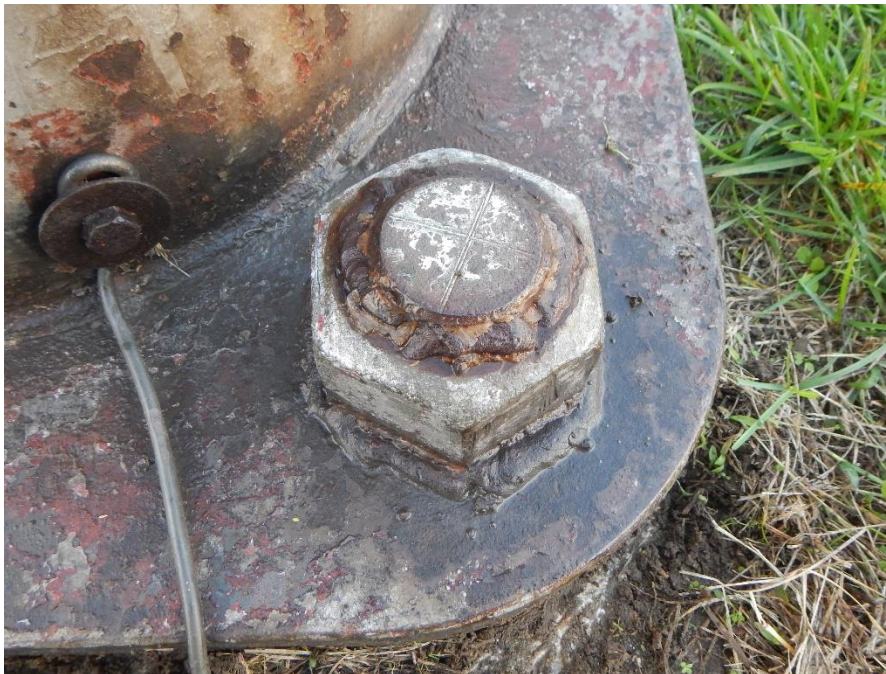
- **Welded Nuts:** The nuts at all poles with the exception of the West Middle Pole were welded to the anchor bolt and base plate (Figure 8). Weld was installed around the full perimeter of the nut at the anchor bolt and base plate. Significant weld undercut was observed at the top toe of the fillet weld above the nut at several anchor bolts (Figure 9).

Figure 8. Nut welded to anchor bolt and base plate.

- **Welded Nuts:** It is unclear why the nuts were typically welded to the anchor bolt and base plate. It should be noted that welding anchor bolt nuts to the anchor bolts or baseplates is not a recommended or accepted practice. If done to prevent the nuts from loosening, a tack weld connecting the nut to the base plate or anchor bolt would have been sufficient. It is possible the welds were installed to compensate for an undersized nut during original installation but in the absence of additional documentation or analysis we cannot comment on the adequacy of the existing nuts. There was no deformation, cracking or other indications that the existing nuts were not performing as intended. The weld has reduced the section of the anchor bolt in some locations due to undercut at the anchor bolt during welding, but this only occurs above the nut where stresses in the anchor bolt are low.

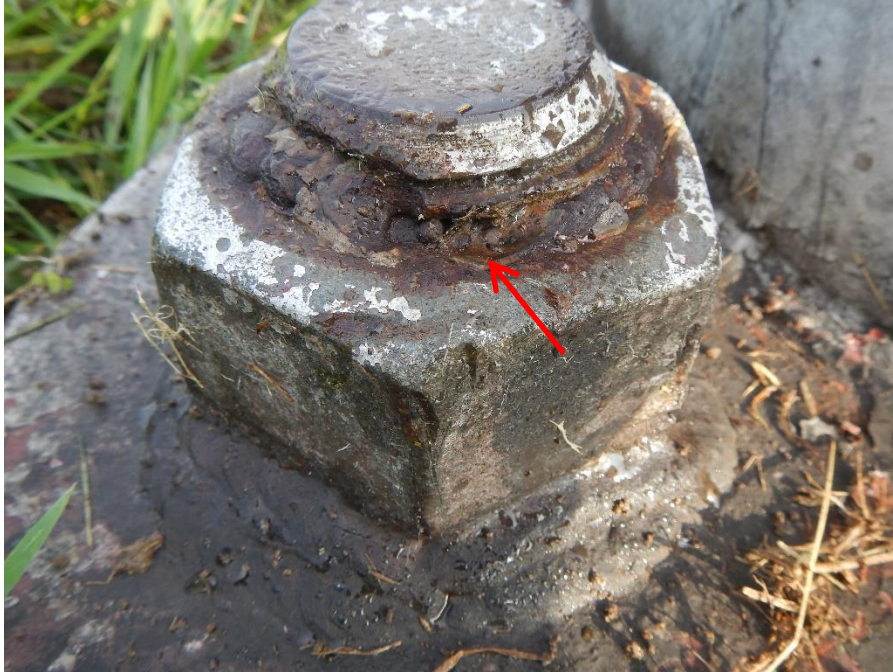
Figure 9. Section loss of anchor bolt at weld installed between nut and anchor bolt.

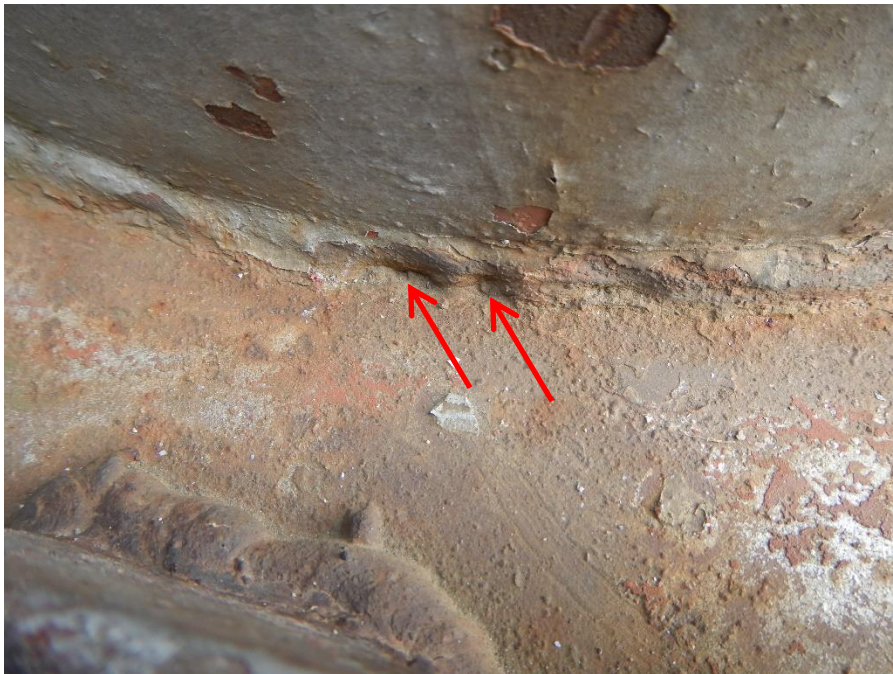
- **Weld Undercut:** At all poles, minor to moderate undercut was typically observed at the bottom toe of the exterior fillet weld connecting the base plate to the pole (Figure 10). The undercut was typically observed in the top surface of the base plate and not the pole.

Figure 10. Undercut and poor profile at weld between pole and base plate.

- **Weld Undercut:** Weld undercut reduces the cross sectional thickness of the base metal and can reduce the capacity of the weld. Based on our observations made during the assessment, the pole passes through a hole in the base plate and is welded to both the top and bottom of the base plate. This type of connection is typically referred to as a socket connection. This socket connection is not solely reliant on the top or bottom weld. The undercut observed in the weld connecting the pole to base plate was typically minor and was primarily in the base plate which is much thicker than the pole. The extent of section loss in the base plate was insignificant as compared to the thickness of the base plate. Additionally, the undercut has been present since the time of original fabrication of the poles and has not resulted in any observed deformations or distress.

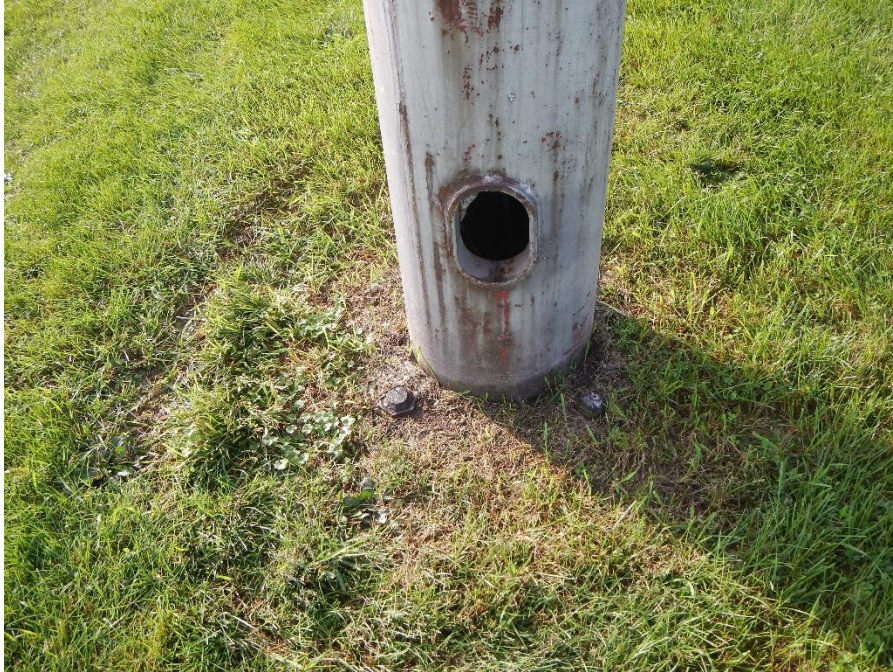
- **Soil Surrounding Pole:** Soil covered the base plate and a portion of the nuts and anchor bolts at the Northeast and Southeast Poles (Figure 11). Soil covered the foundations and grout under the base plate at the Northwest and Southwest Poles (Figure 12). The foundation was exposed at the East Middle and West Middle Poles (Figure 13).

Figure 11. Soil covering base plates and part of anchor bolts and nuts.

- **Soil:** The soil covering the base plates of the Northeast and Southeast Poles can trap moisture against the poles and anchorages leading to accelerated corrosion. The height of soil observed inside all the poles varied but was in direct contact with the base plate in some locations and the anchor bolts and leveling nuts below the base plate where they are not encapsulated by grout. Where soil is in direct contact with steel elements it can lead to accelerated corrosion.

3. Soil: We recommend the soil covering the base plates, anchor bolts, nuts, grout and foundations at the Northeast, Southeast, Northwest and Southeast Poles be removed to expose the top of the foundation and prevent accelerated corrosion of these components. The soil should be lowered several inches below the top of the foundations and graded away from the pole foundation to drain surface water away from the pole. Depending on the soil elevation beyond the area immediately around the pole, additional drainage modifications may be required to allow water to drain away from the foundation.

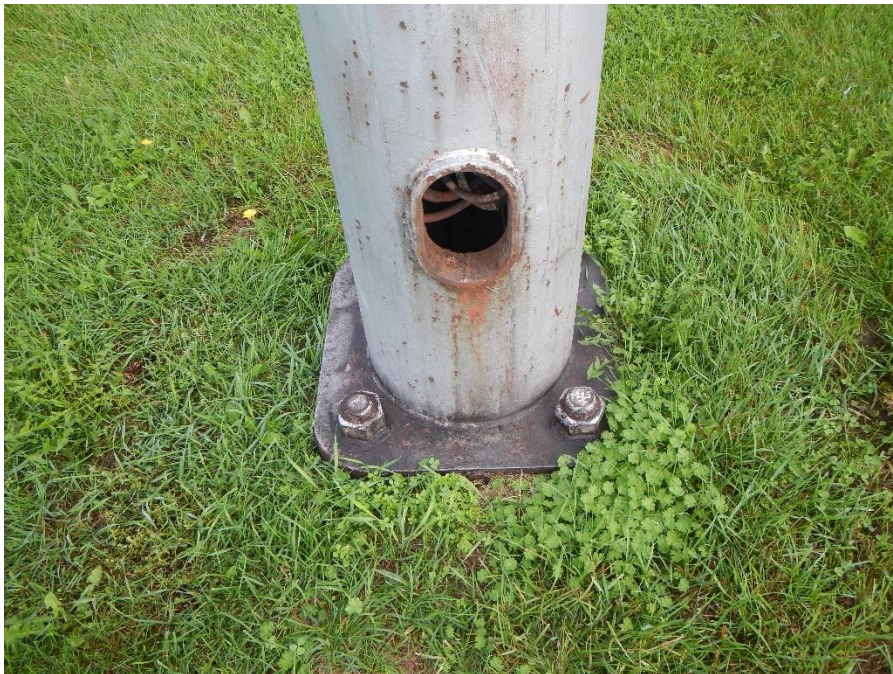
Figure 12. Soil covering foundation and grout at Northwest Pole.

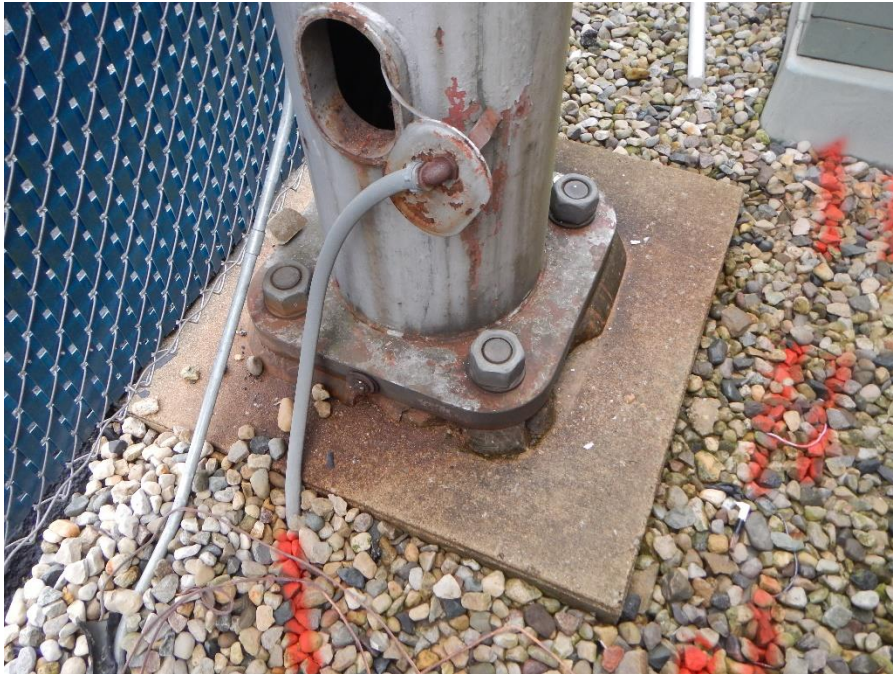
Figure 13. Concrete foundation at base of West Middle Pole.

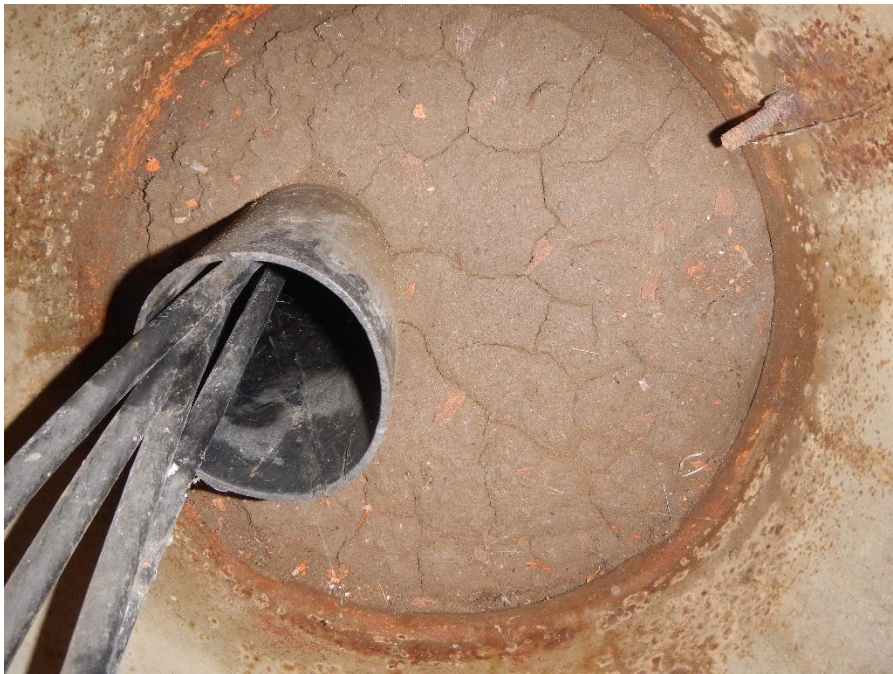
- Soil Inside Pole: Soil was typically observed inside the poles at their bases (Figure 14). The depth of soil varied and, in some locations, extended onto the base plate inside the pole.

Figure 14. Soil inside pole as seen through hand hole opening.

leveling nuts cannot be confirmed from inside the poles, local removal of small areas of grout at the remaining anchor bolts should be performed to confirm their presence. Assuming leveling nuts are present at all anchor bolts and properly installed, we recommend the grout be removed in order to remove the soil that has accumulated inside poles and inspect the anchor bolts and leveling nuts. If any significant corrosion induced section loss or other deleterious conditions are observed at the leveling nuts or anchor bolts, the conditions should be further evaluated to determine if additional remedial measures are required. After the anchor bolts and leveling nuts have been inspected and assuming they are deemed acceptable for reuse, these elements should be coated in accordance with the recommendations of Item 5. We recommend that protective stainless steel screens be installed or the grout under the base plate be reinstalled to prevent the accumulation of debris under and inside the pole.

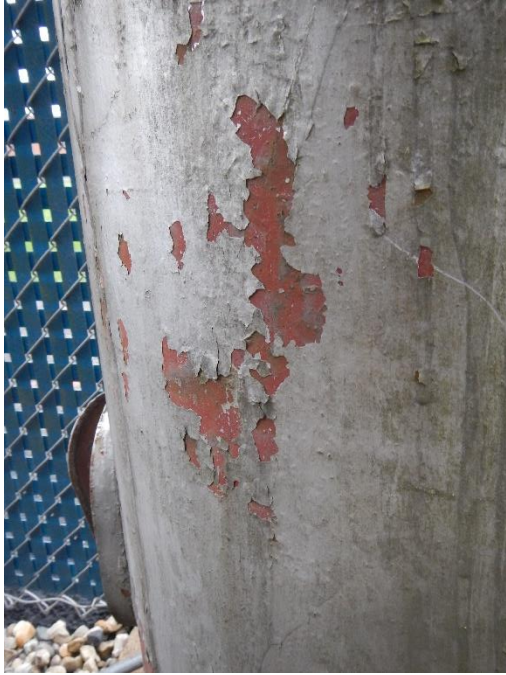
- Coating: The painted coating which was applied to the pole, base plate, nuts and anchor bolts was compromised at all poles with missing, chipped and flaking paint (Figure 15). The coating on the upper portions of the poles was typically in better condition than the coating lower down but some compromised coating higher up was observed. Minor uniform surface corrosion was typically observed where the coating was missing and the steel surface of the pole was exposed (Figure 16). In all cases, corrosion-related section loss was insignificant. The interior surface of the poles was also painted. The condition of the coating on the interior pole surface was typically similar to or worse than that observed on the pole exterior (Figure 17).

Figure 15. Failed coating on exterior surface of pole.

- **Coating:** The extent of coating damage was relatively significant with large areas of failed coating on the pole exterior and interior, base plate, anchor bolts and nuts. The related corrosion where the steel was exposed is currently not significant. However, if not addressed, corrosion of unprotected areas will continue and could compromise the poles in the future.

5. Coating: We recommend that all exterior surfaces of the poles and their anchorages be recoated with an appropriate coating system applied in accordance with the manufacturer's specifications. All poorly bonded existing coating should be removed. Where the existing coating is well bonded, it may remain assuming the new coating system is compatible with overcoating of the existing. The surface of the steel pole where exposed and the existing coating to remain should be prepared in accordance with the coating manufacturer's recommendations. The interior surface of the pole is not accessible for recoating. As noted, the observed corrosion has not compromised the capacity of the pole at this time. It is recommended the poles be inspected on a regular basis to identify areas of corrosion which could potentially compromise the poles. Refer to Item 7 for details.

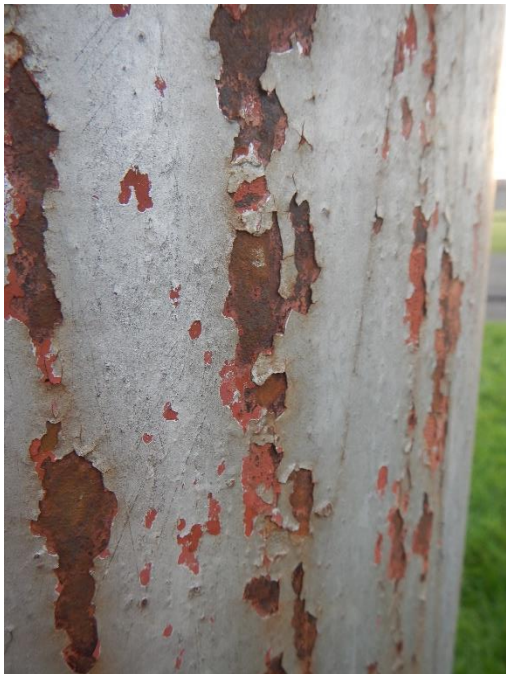
Figure 16. Uniform corrosion of pole at area of failed coating.

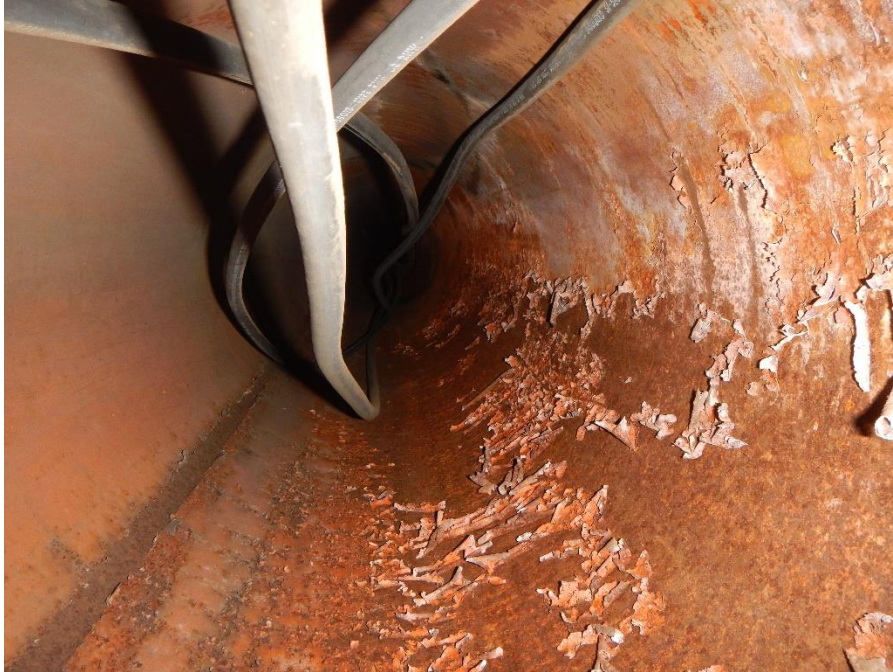
Figure 17. Failed coating on interior surface of pole.

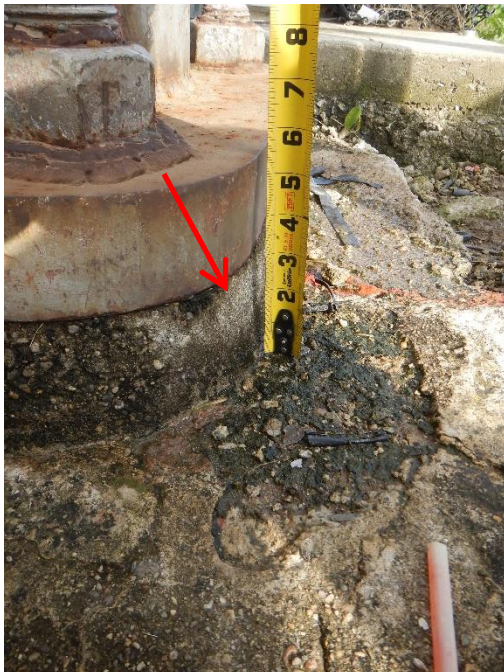
- Grout: The gap between the base plate and foundation was grouted (Figure 18) but leveling nuts were observed at some of the poles through the hand hole opening (Figure 19). A portion of the grout under the base plate at the West Middle Pole was spalled and unsound (Figure 20).

Figure 18. Grout installed under base plate of East Middle Pole.

- **Grout:** The grout observed between the foundation and base plate of the poles is likely not structural as evidenced by our observations of leveling nuts at accessible locations through the hand hole and was probably installed to prevent accumulation of debris under the poles.

4. Grout: Leveling nuts were visible from inside the pole at some locations, but it shall be confirmed that leveling nuts exist at all locations and that they are in full contact with the base plate. Verification can be done by means of a borescope or other visual means from inside the poles. If the presence of

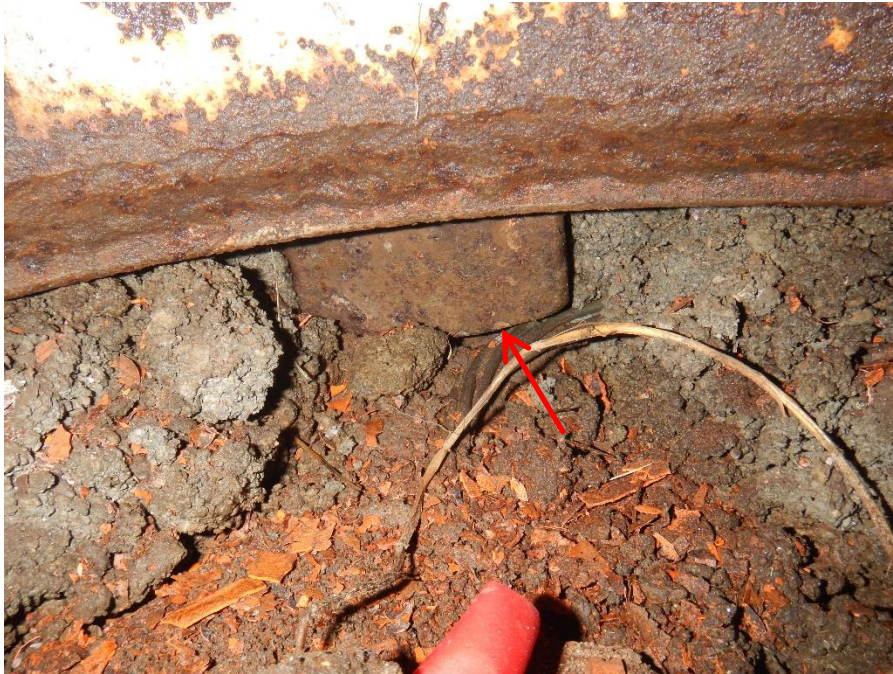
Figure 19. Leveling nut under base plate as seen through hand hole opening.

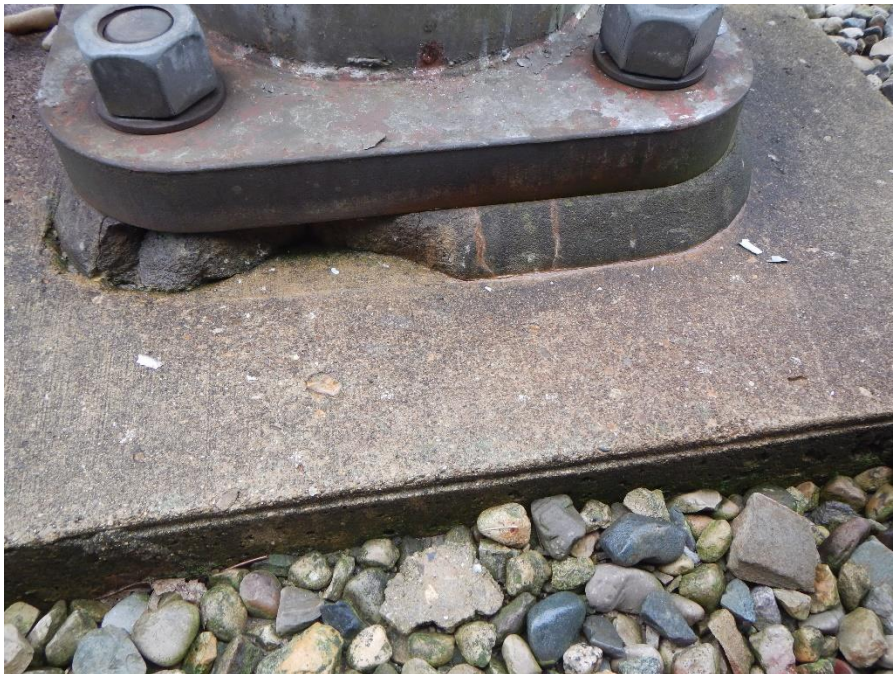
Figure 20. Spalled grout under West Middle Pole.

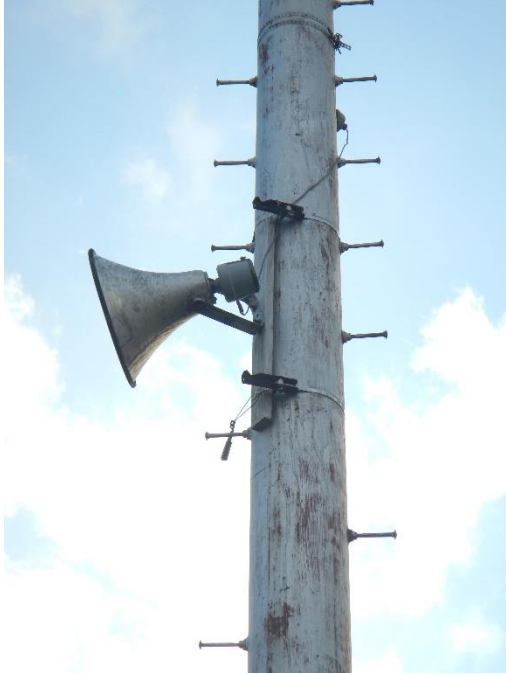
- Speaker Attachment: Speakers were attached to the Southwest and Northwest Poles via wood blocking and light gauge steel straps (Figure 21).

Figure 21. Speaker attached to Southwest Pole via wood blocking and steel straps.

- **Speaker Attachment:** The attachment of the speakers to the Southwest and Northwest Poles did not appear to be designed and may not have the necessary capacity to resist design level wind loads. Although not observed, if the wood blocking begins to decay, the connection could loosen compromising the support of the speaker. Also, since the speaker attachment does not appear to be designed, it is also possible that the original pole was not designed for the additional wind loads imposed by the speaker.

6. Speaker Attachment: We recommend the existing connection of the speakers to the Northwest and Southwest poles be replaced with a new connection designed to resist the code prescribed wind loads. We recommend the connection use hot-dip galvanized or stainless steel components to prolong the life of the connection.
