October 20, 2021

Tipton High School Light Pole Assessment

WJE No. 2021.6711

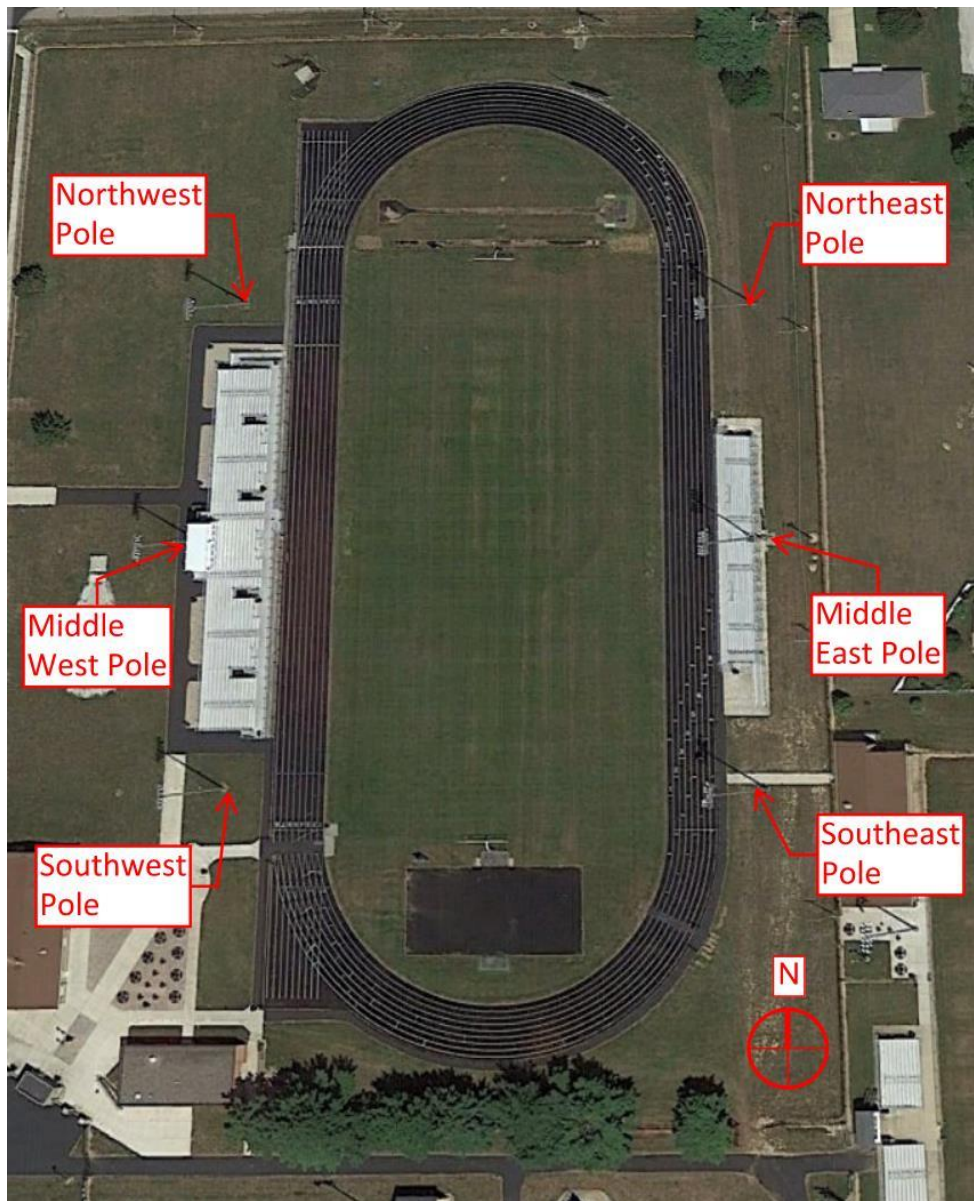
Figure 1. Aerial view of track and football field with each pole identified. Note, photo acquired from Google Earth, annotations added by WJE.
