TIPTON COMMUNITY SCHOOL CORPORATION
MEMORANDUM

RE: **Roof Project**

Tipton School Corporation

Summer 2020 Roof Replacement Projects

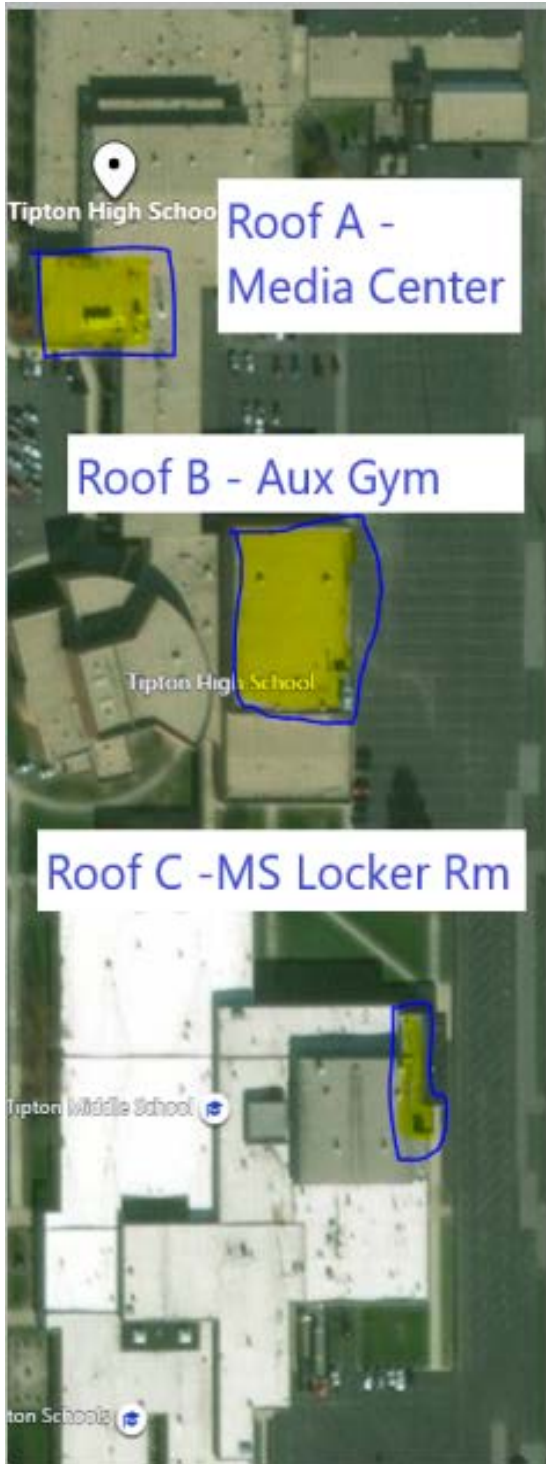
The following outlines the proposed scope and price for the roof replacement project. All three roof

projects are based on replacing the foam roofing system that has exceeded its expected useful life with a new PVC roof – similar to the newer roof systems on the building.

Media Center Roof (A) Price - \$202,856.00

Auxiliary Gym Roof (B) Price - \$383,094.00

Locker Room Area Roof (C) Price - \$47,976.00
